Appendix D – Geotechnical Engineering Studies

TECHNICAL MEMORANDUM

SUBJECT: **FIELD VISIT - OBSERVATIONS AND CONCLUSIONS**
Bow Lake Transfer Station/Recycling Facility
King County, Washington

PROJECT NO.: 2003-008-21

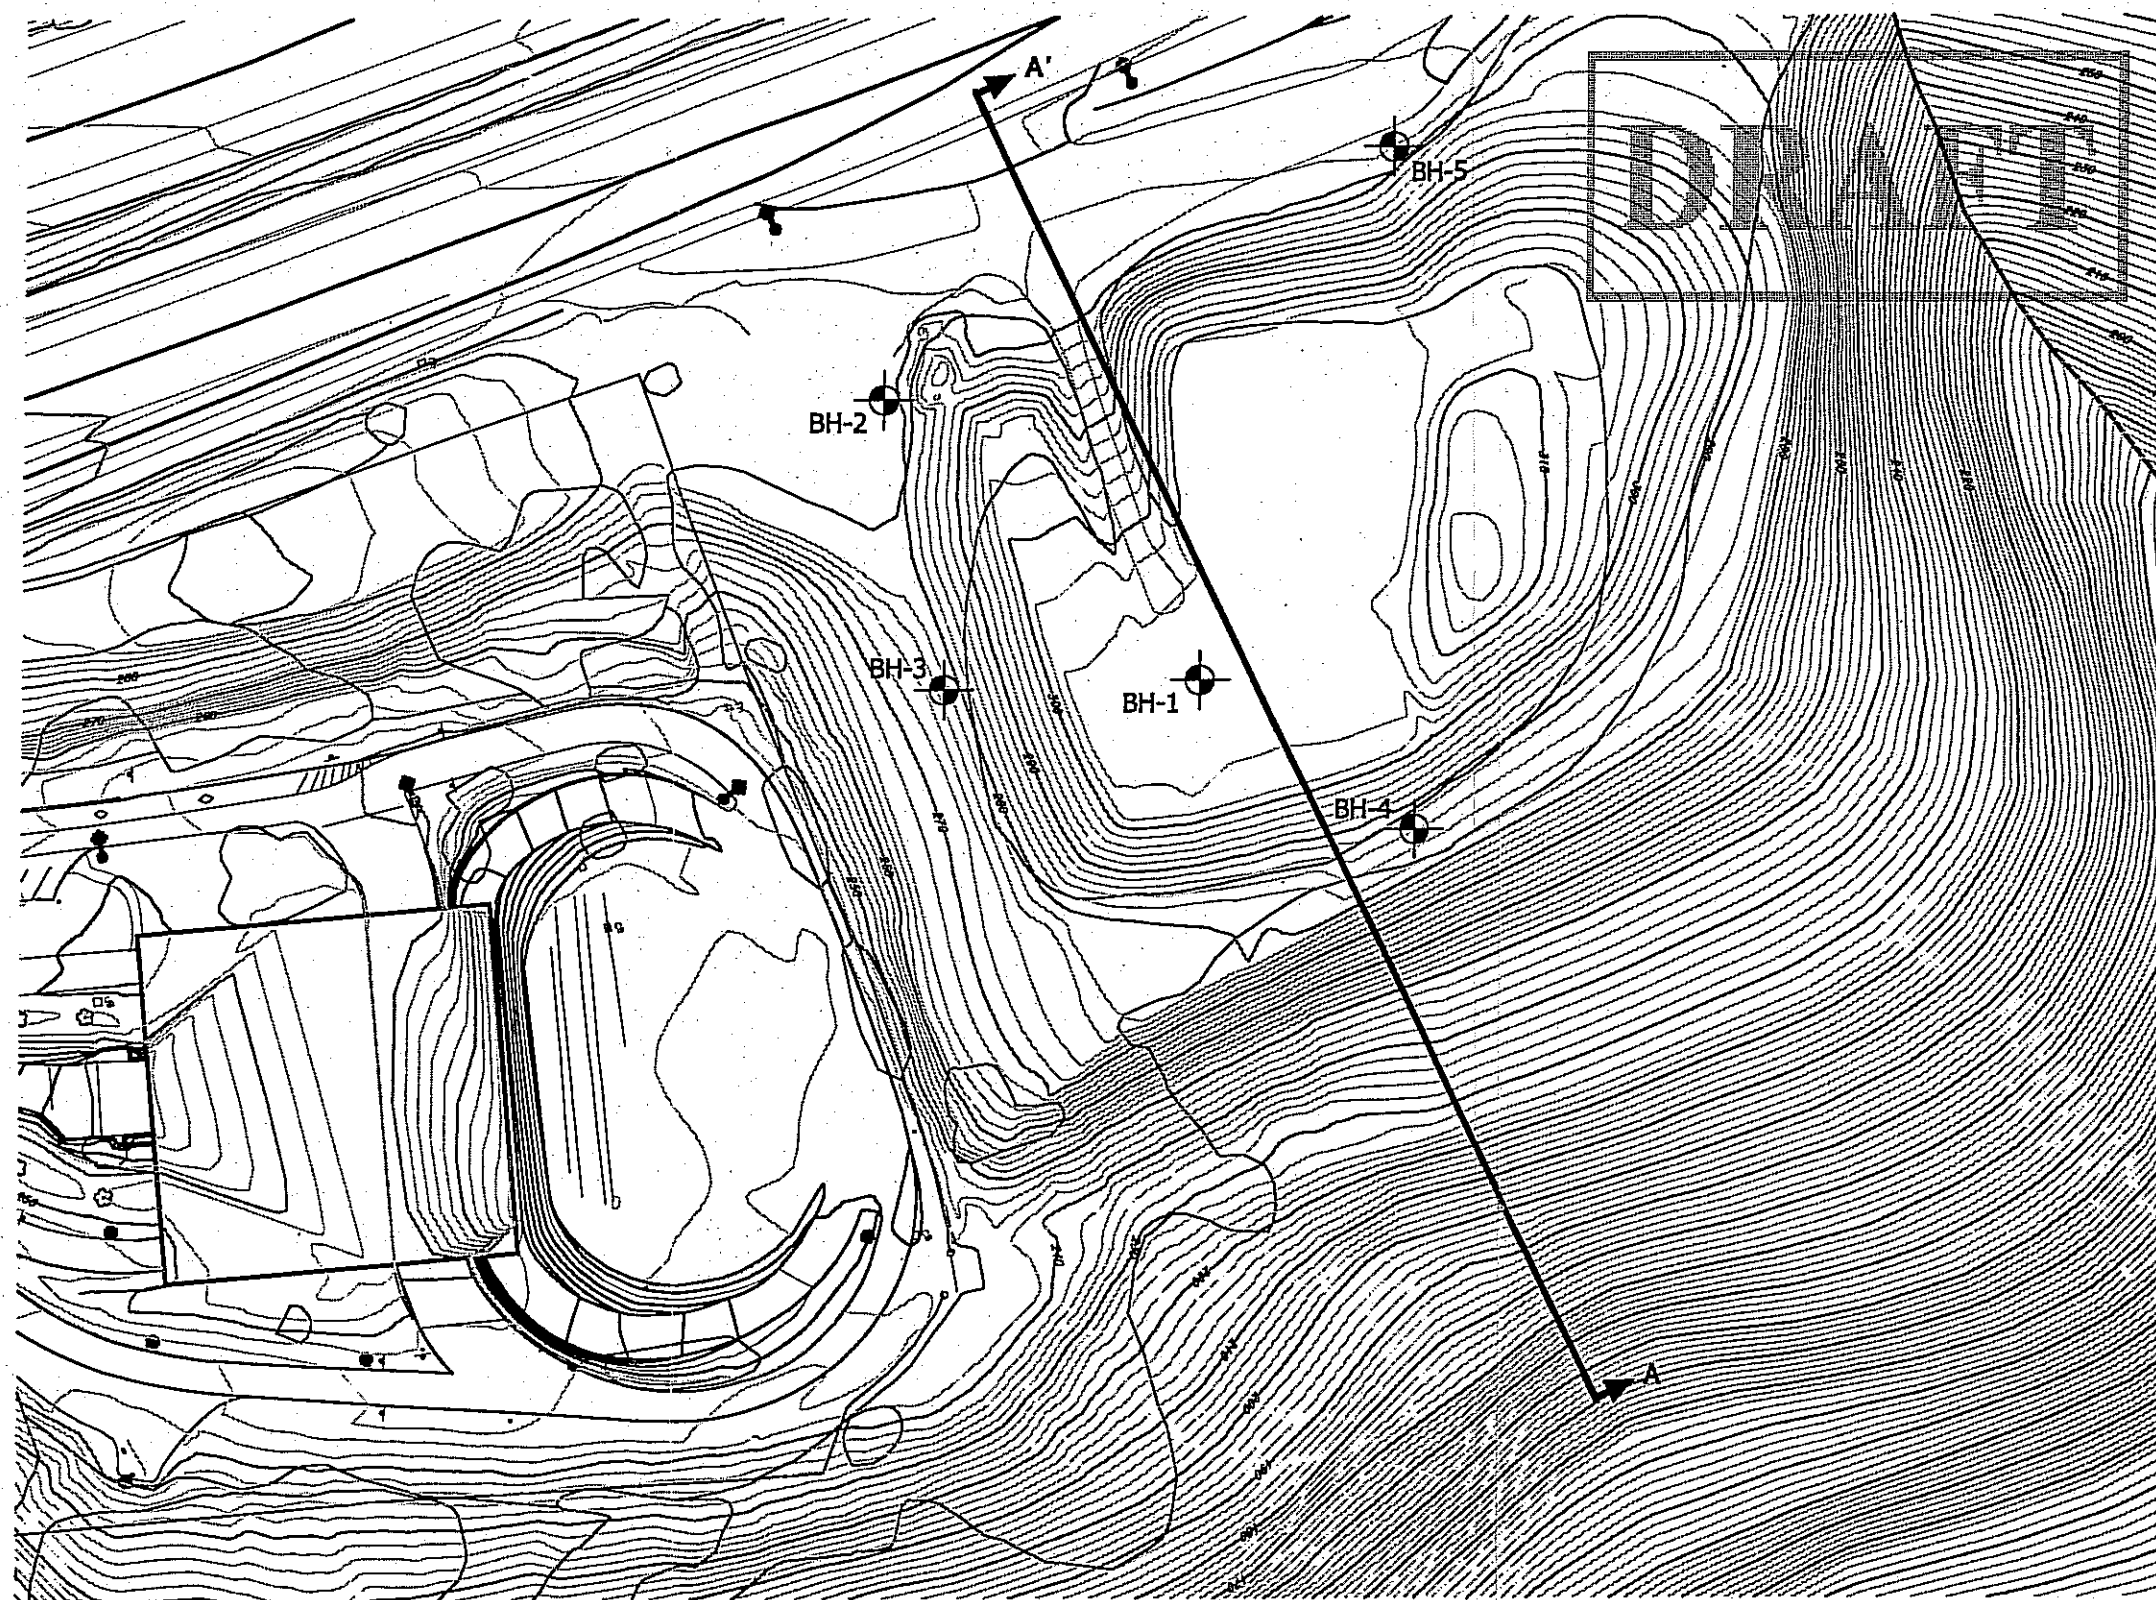
FIGURE NO.
2
PROJECT NO.
2003-008

Approximate boring locations are shown on the Site and Exploration Plan (Figure 2), which is an extract from a topographical site survey provided to HWA by R.W. Beck on December 16, 2003. It should be noted that the boring locations are approximate because of discrepancies between the survey co-ordinates on the survey drawing and exploration location co-ordinates supplied by surveyors on October 10, 2003.
